SUBJECT: Testing of Trico Aluminum Products 58" x 53-1/8" Unit Skylight sample to the methods outlined in the following standards:

This summary letter confirms that the Trico Aluminum Products 58" x 53-1/8" Unit Skylight has been tested to methods outlined in ASTM E283 and ASTM E547 standards with the following results:

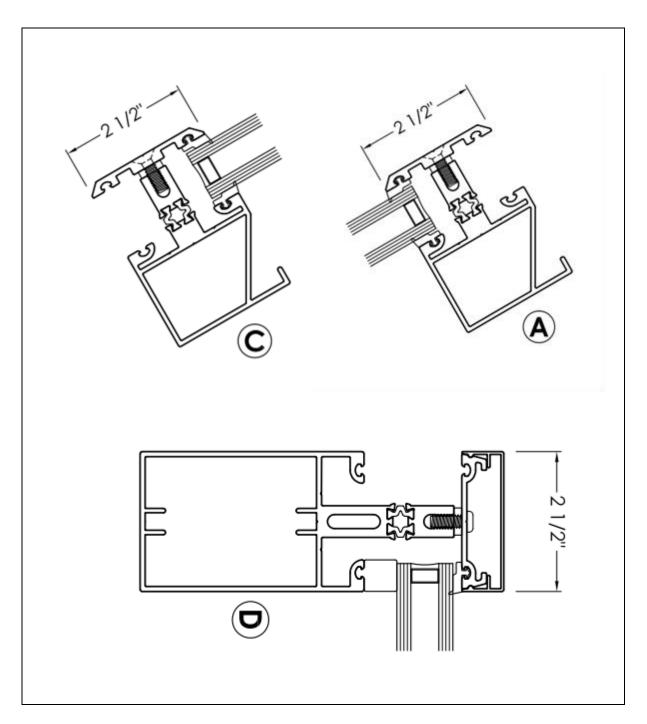
Assembly Drawings.

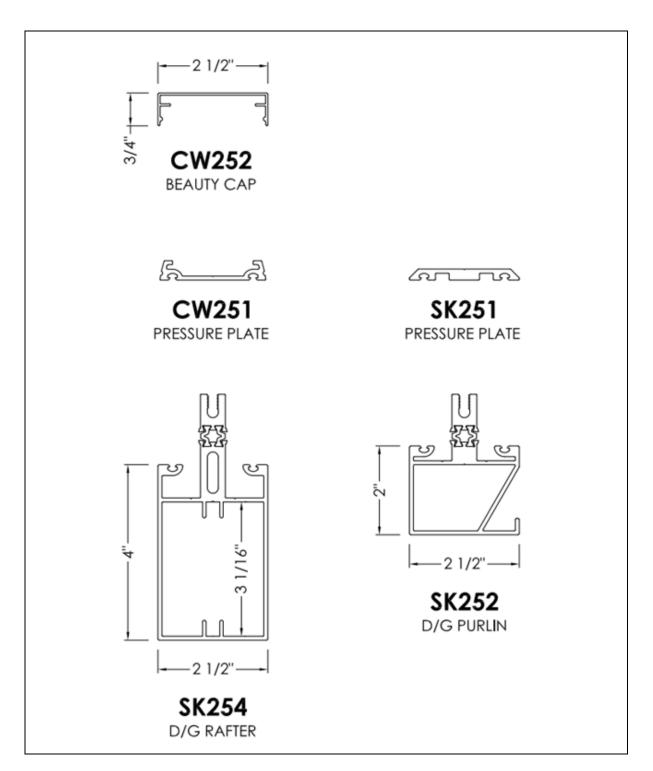
Parts Drawings.

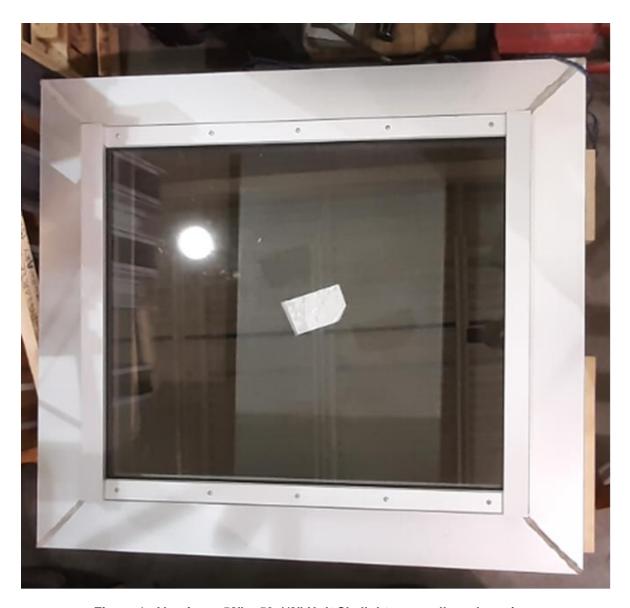
Figure 1: Aluminum 58" x 53-1/8" Unit Skylight – overall product view.

- Test sample was installed on a 1:240 slope during test.
- Test sample dimensions (width x height): 58" x 53-1/8" (1473 mm x 1349 mm) when measured to the outside of the curb.

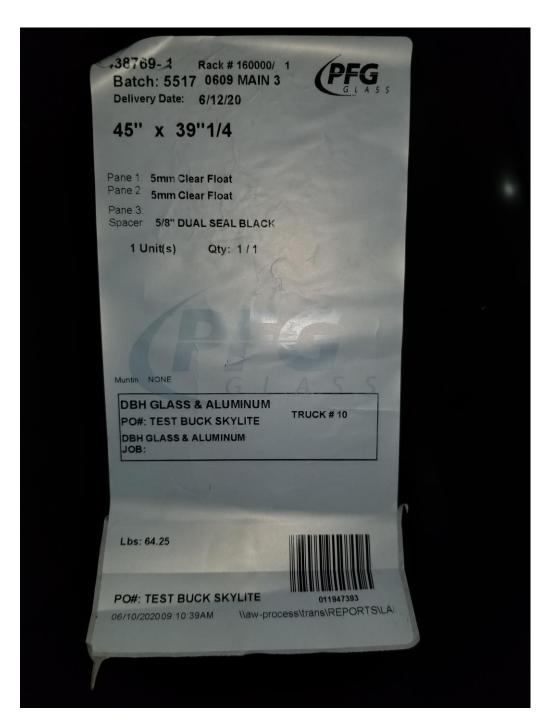
Figure 2: IGU Details.

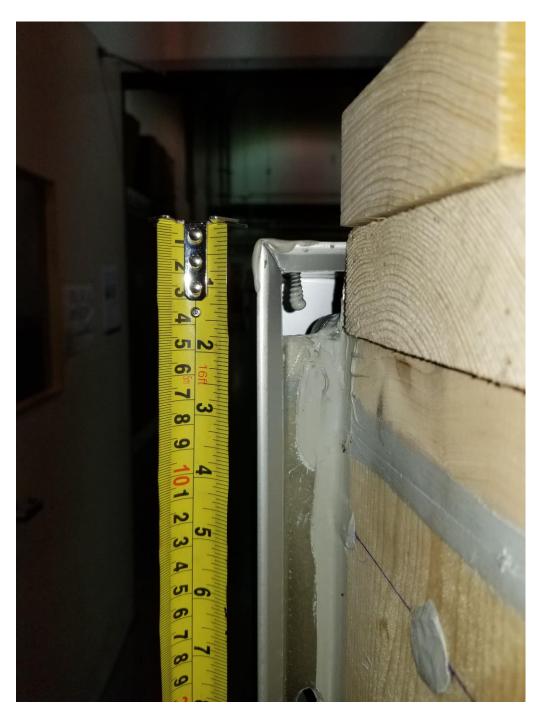
Figure 3: Exterior flashing corner fastener and sealant.

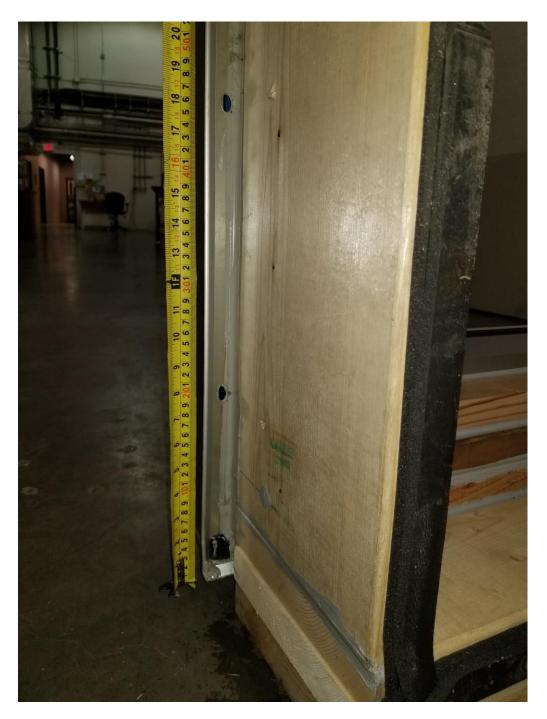
Figure 4: Exterior drainage.

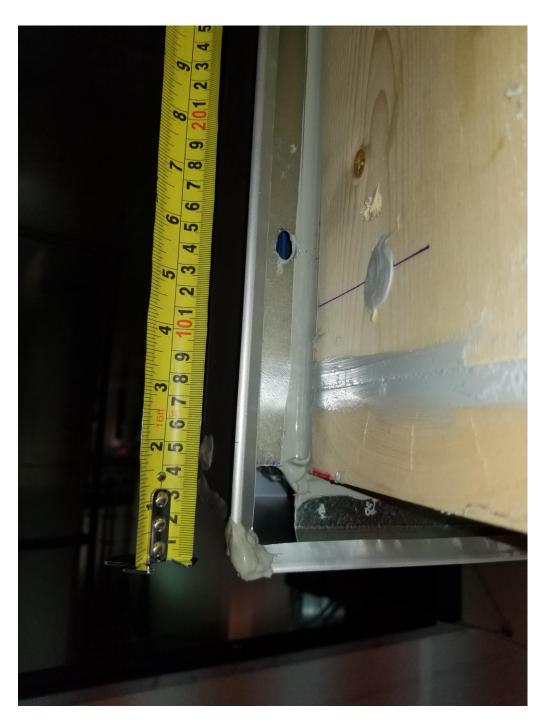
Figure 5: Exterior drainage at flashing corner.

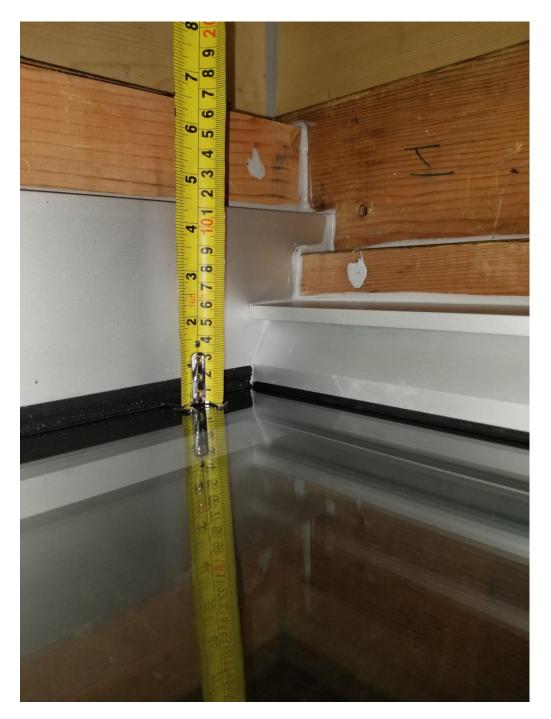
Figure 6: Bottom interior corner and sealant.

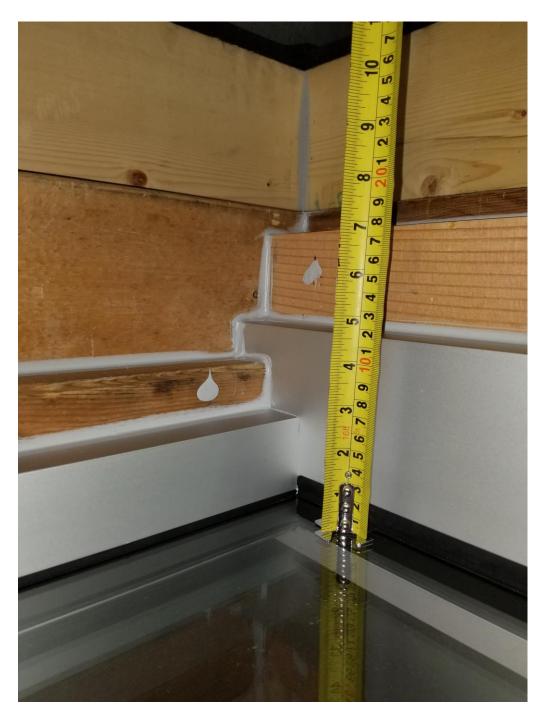
Figure 7: Top interior corner and sealant.
